Mariners' Alerting and Reporting Scheme

MARS Report No. 317 March 2019

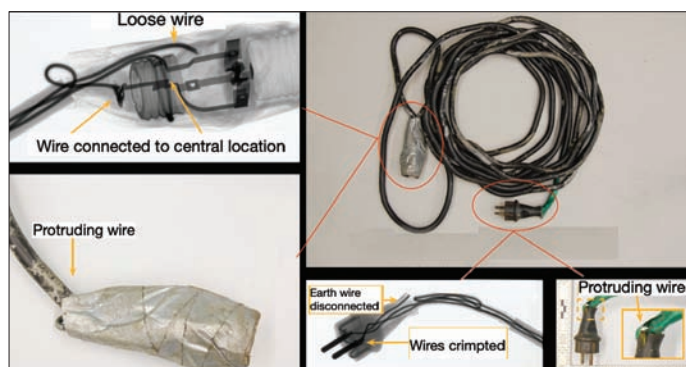
Work was stopped for coffee. When they returned to the tank, the bosun was carrying cable that had a lamp fixed to one end and a plug on the other. Tape was wrapped around both the lamp's fitting end and the plug end. The bosun inserted the plug in a wall socket near the tank and took the lamp into the tank.

The report found that the victim probably died as a result of electrocution from direct contact with the live wire as a result of the opening in the cable covering, although other causes could not be ruled out entirely.

- Inadequate supervision, as in this case, can have disastrous consequences.
- Under no circumstances should electrical cords be improvised, repaired or otherwise jury-rigged. Only undamaged, intact cords that are manufactured for such use should be employed. Better yet, use battery-powered lighting in confined spaces.
- Never underestimate the deadly power of ship's main electrical power.

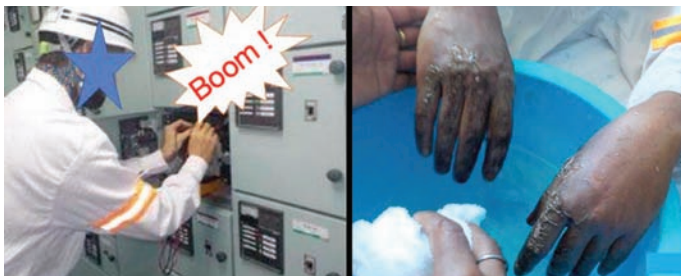
➔ An engine room crew member was investigating problems with the fuel oil circulating pump at the circuit breaker board. The pump's breaker was opened and he proceeded to check the isolation status of the breaker terminals with a multimeter. As soon as he touched the terminals with multimeter leads, a huge spark emanated from the breaker/multimeter, with a loud explosive sound and black smoke.

The victim sustained burns on his face, neck and hands due to radiant heat. He was given first aid and signed off from the vessel for further medical attention ashore. The investigation found that he had attempted to check the voltage across breaker terminals with the multimeter selector knob at the Resistance (1 Ohm) setting instead of the Voltage (1000VAC) setting. The electric charge found its shortest path (through the multimeter), which then exploded. It was also found that the victim had failed to use insulating gloves which would have decreased the severity of the injury.

- Approved insulated gloves should be used while working on electrical components.
- It is always a good idea to cross-verify your tool and workplace before starting the job;
 - Is the guard in place?
 - Is the setting correct?
 - Is the electrical supply safe?
 - Is the lighting adequate?

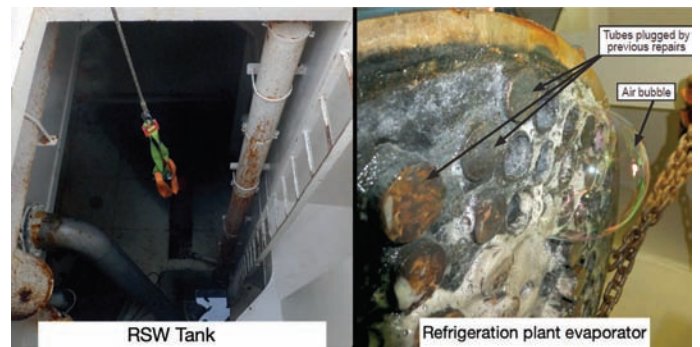
Following the accident, tests of the atmosphere in the tank showed that the level of oxygen at the bottom was less than 6% (normal level = 20.9%). Further tests indicated the presence of Freon R22, the refrigerant gas used in the RSW tank's refrigeration plant.

The official investigation found that the refrigeration plant evaporators had suffered several tube failures necessitating a number of repairs. It is likely that Freon leaked through one or more failed tubes into the seawater system and was released into the RSW tank. Freon R22 is four times heavier than air so it will displace oxygen at the bottom of an enclosed space. It is a toxic, tasteless and mostly odourless gas. If it is deeply inhaled, it can cut off vital oxygen to blood cells and lungs.

- All enclosed spaces on a vessel should be identified.
- Entry into any enclosed space should be regulated by a procedure that includes ventilation of the space and testing of the air prior to entry. Additionally, the procedure should include close and continuous supervision by a qualified crew member (safety sentry) at the entrance to the space while it is occupied.
- If an emergency occurs in an enclosed space, entry should only be attempted by crew members wearing breathing apparatus.

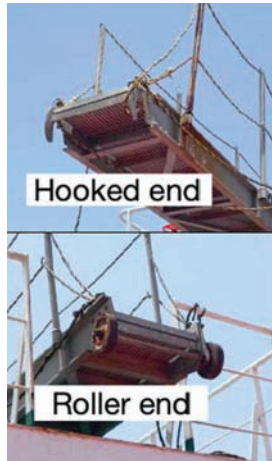
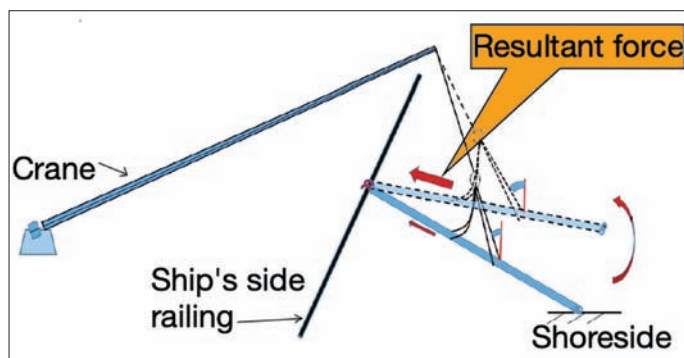
Tension was brought on the lift but the hooked end remained stuck on the vessel's railing. As the chief officer moved closer to examine the problem, the hooks suddenly released from the railing. Because the crane's hook, attached to the gangway sling, was not under the head of the boom, the gangway shifted inboard in an uncontrolled manner. It struck the chief officer, pushing him up against a nearby water ballast tank vent-head.

- Decisions as to fitness for duty after an injury should not be left exclusively to the victim. Company procedures should give guidance to Masters and crew on actions subsequent to diagnosis.
- Every lift should be carefully undertaken with regard to keeping the boom-head directly over the hook.

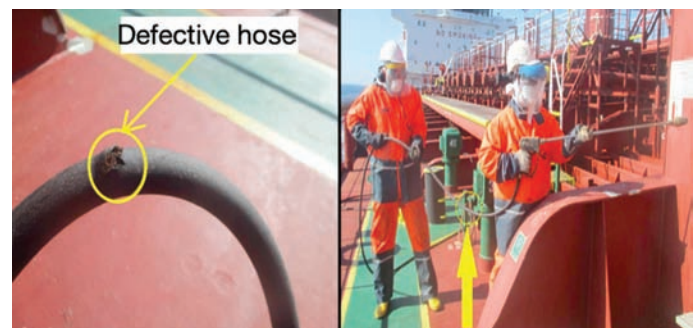
→ After the daily toolbox meeting, the deck crew began scaling operations using a pressure washer. Each crew member was dressed in the required PPE to carry out this task: helmet, full-face mask, dust mask, overalls, gloves and boots. As they were working, the high-pressure water hose suffered a sudden leak near the two crew. The surprise and the force of the pressurised water leak caused the crew to lose control of the hose and they suffered impact from the backlash of the uncontrolled hose.

- Close inspection of powered or pressurised equipment before use should be a best practice on all vessels.
- In this case, the crew's PPU probably reduced the severity of their injuries considerably.
